## **IMIDE/GRAPHITE COMPOSITE DEGRADATION MECHANISM**

Final Report  
Contract No. N00019-94-C-0207  
Contract Amount: \$58,801.30  
Contract Competitively Awarded

NAV-0207-FM-95123-934

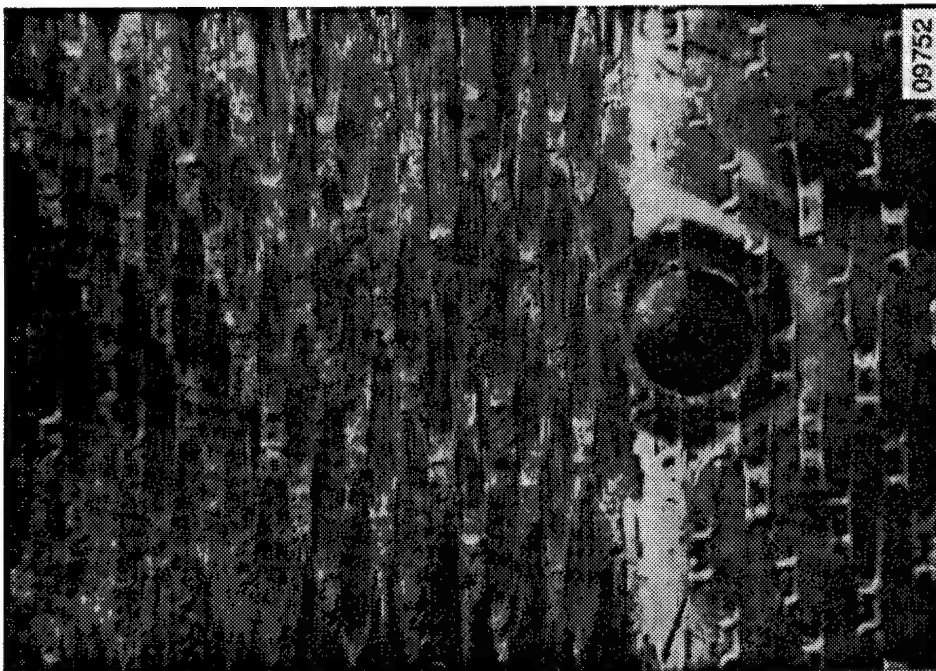
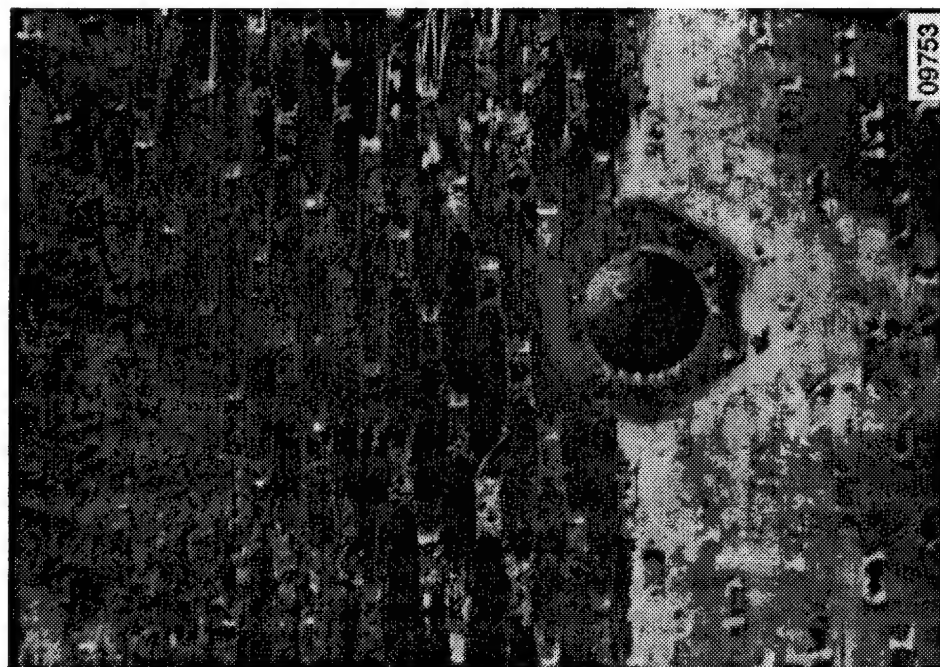
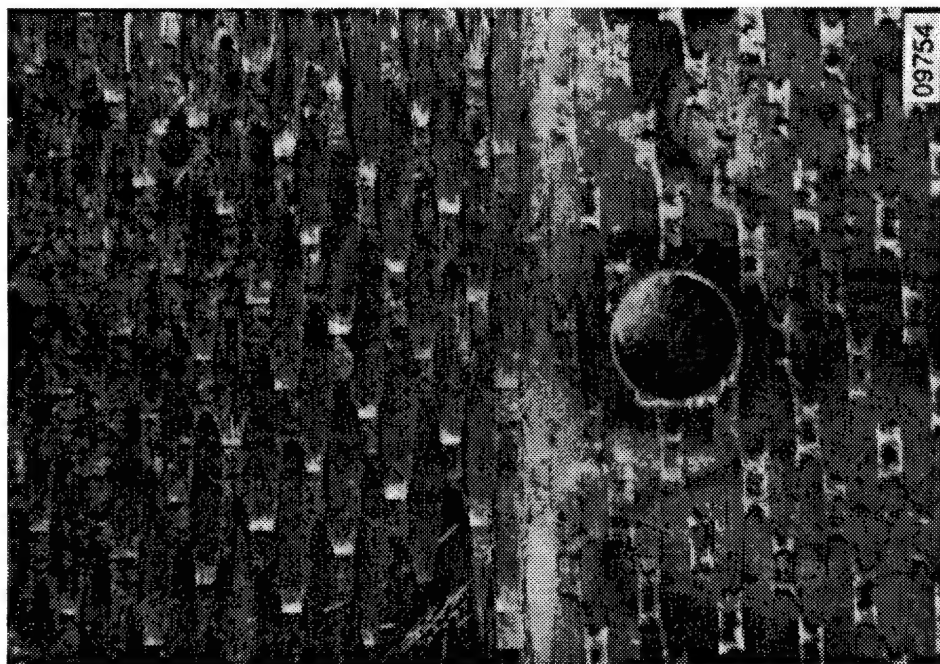
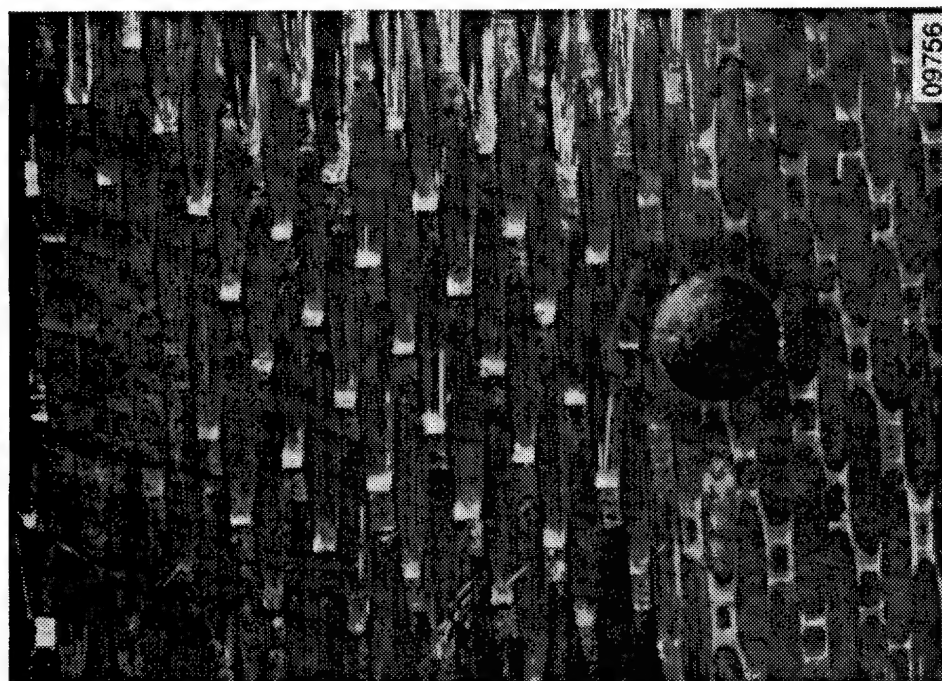
**Figure 10a.** Close-up view of an uncorroded BMI control sample

**Figure 10b.** Close-up view of a BMI control sample corroded 96 hr at 80°C

**Figure 10c.** Close-up view of a Matrimid 5292 sample corroded 96 hr at 80°C

**Figure 10d.** Close-up view of a Plenco 12505 modified sample corroded 96 hr at 80°C

**Figure 10e.** Close-up view of a Penacolite B-1A modified sample corroded 96 hr at 80°C

**Figure 10f.** Close-up view of an epoxy coated fiber sample corroded 96 hr at 80°C

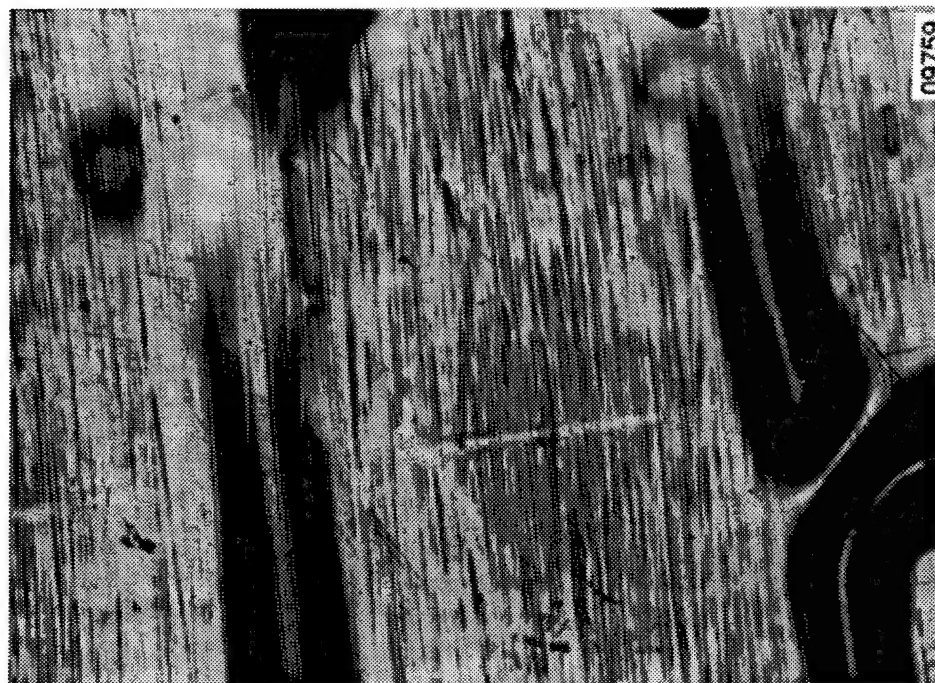
**Figure 14b.** A view of the uncorroded BMI control sample showing a region of the sample similar to that in Figure 14a

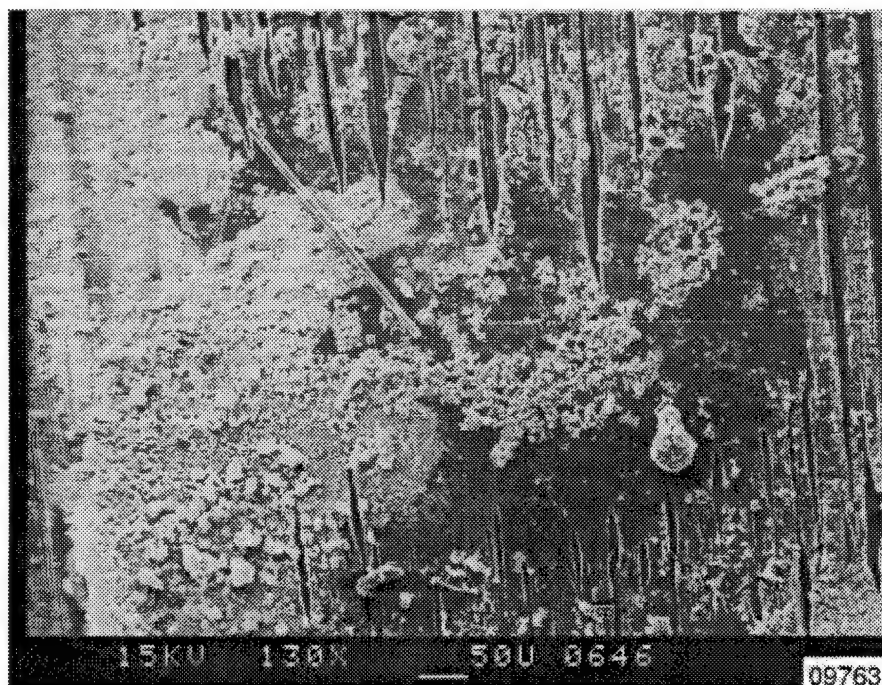
A) THE UNCORRODED CONTROL SAMPLE, TAKEN NEAR THE INTERSECTION OF WOVEN FIBER TOWS. EMBEDDED SURFACE FIBERS ARE SEEN IN TWO SMALL SURFACE VOIDS

**Figure 18. 130x views of BMI control and Matrimid samples which were uncorroded and corroded for 48 hr at 80°C**

B) THE CONTROL SAMPLE CORRODED FOR 48 HR, VIEWED IN A REGION WELL BELOW THE SALTWATER-JET FUEL INTERFACE. NOTE THE EXTENSIVE MICROCRACKING OF THE RESIN

C) THE MATRIMID SAMPLE CORRODED FOR 48 HR, VIEWED IN A REGION WELL BELOW THE SALTWATER-JET FUEL INTERFACE. NOTE THE SURFACE VOID SIMILAR TO THAT IN FIGURE 18A, AS WELL AS THE EXTENSIVE MICROCRACKING OF THE RESIN

Figure 18 shows uncorroded control, 48 hr corroded control, and 48 hr corroded Matrimid samples at 130x. Figures 18b and 18c are taken well below the saltwater-jet fuel interface. Microcracking along the fiber direction is evident in both of the corroded samples. Similar regions from these samples, taken at 360x, are shown in Figure 19. A 1600x view of a region where microcracks are initiating in the 48 hr corroded sample is shown in Figure 20. The surface texture present here appears to be deposits of salts and corrosion by-product, and not pitting, since it is absent in other corroded areas. The small cracks appear to be propagating slowly until they reach a critical size. Unlike the microcracks in Figure 18, the edges are rough, as if caused by chemical degradation. The straight, smooth cracks in Figure 18 are more indicative of rapid, unstable crack growth, which probably occurred when initiating microcracks reached a critical size.
